REMR TECHNICAL NOTE CS-MR-8.5

CASE HISTORY OF IMPROVING STRUCTURAL STABILITY OF CONCRETE STRUCTURES ON ROCK: INSTALLATION OF ROCK ANCHORS TO IMPROVE STABILITY AGAINST OVERTURNING, LOCK NO. 3, MONONGAHELA RIVER*

PURPOSE: To present a case history of improving stability of a structure against overturning.

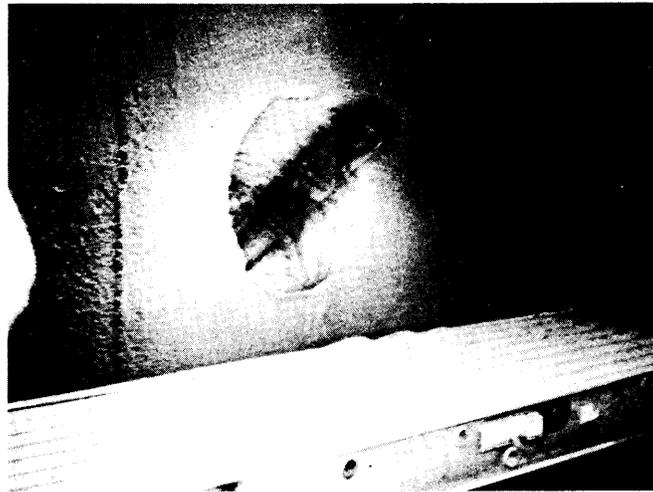
Installation of the filling flume anchors was especially difficult because the anchor heads downstream of the operations building are located 5 ft below the

top of the filling flume slab (Figure 1). Another difficulty was that high

Figure 1. Installation of filling flume anchors

water is fairly common at Lock 3 and the contractor had to install scaffolding or work platforms inside the flume that could be easily raised. The contractor had to break an opening in the slab and drill at a 1V to 1.5H slope through the concrete retaining wall and the overburden material while advancing a 4-in.-diam casing and, finally, into the rock for a depth of at least 20 ft. The casing was required for corrosion protection and to keep the hole from collapsing while drilling. The hole diameter in rock was 3-1/2 in. for the first stage grouting.

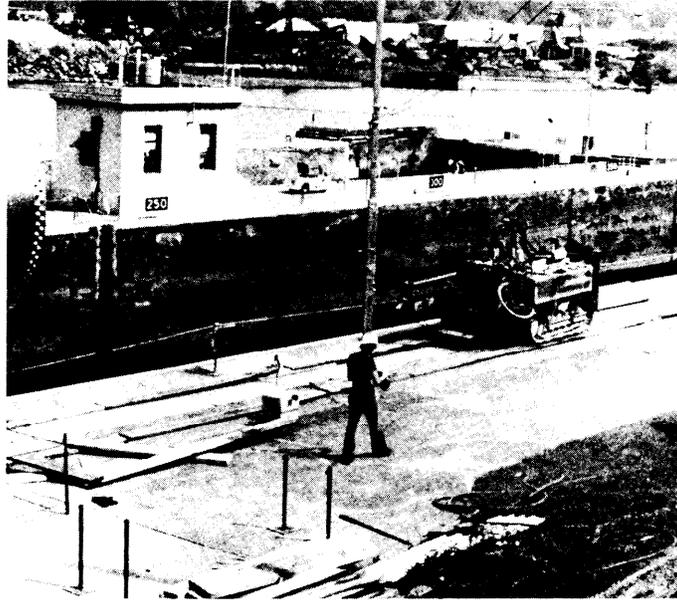
DRILLING EQUIPMENT: The drilling equipment used by the contractor consisted of a crawler-mounted hydraulic drill rig specially designed and built for anchor installation (Figure 2). The contractor was restricted in possibly overloading the slab with his drilling equipment and, therefore, was required to place planking across the beams spanning the deteriorated slab. The beams were not as deteriorated and were found to take a load of 500 psf. The biggest problem the contractor had in installing the anchors was in drilling a hole through abandoned sheet piling in the overburden behind the retaining wall. After some difficulties, the hole was finally drilled to the required depth and the anchor installed.

Figure 2. Crawler-mounted hydraulic drill rig used by contractor

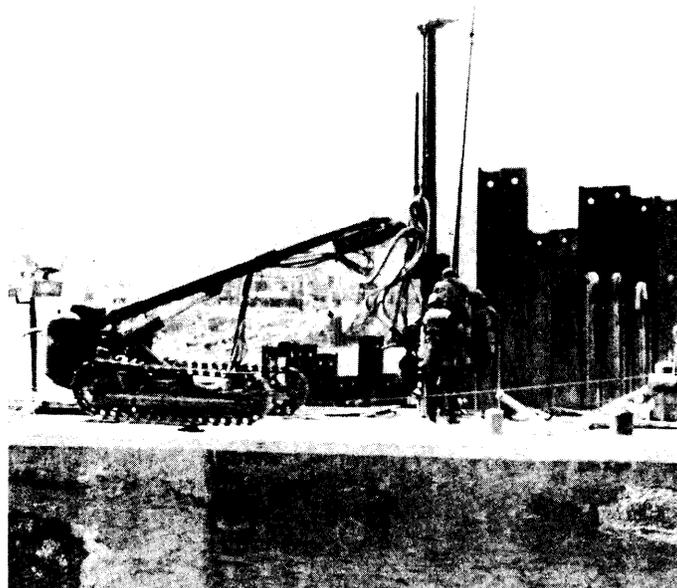
The first critical area near the cofferdam was first stabilized with just vertical rock anchors until the cofferdam was dewatered (Figure 3). It was discovered

Figure 3. Stabilizing and dewatering cofferdam

that these monoliths were formed in the wet without the benefit of today's technology used in placing tremie concrete. As a result, the concrete was segregated and it was apparent that the foundation was not prepared very well when concrete was placed. There was concern that sliding could be a problem and, as a result, nine inclined anchors were installed from within the cofferdam to prevent this type of failure.

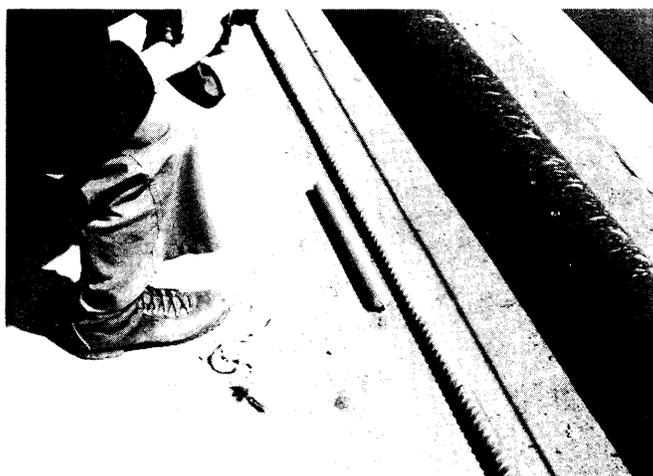
RESIN-GROUTED ANCHORS: Plans and specifications called for cement-grouted anchors grouted in two stages. As an option, the contract allowed the use of resin-grouted anchors (Figure 4). The contractor proposed a hybrid system using

Figure 4. Resin-grouted anchors

resin within the anchorage length in rock and cement grout within the concrete of the lock wall. This resulted in two hole sizes, a 2-1/4-in. hole in rock to allow proper mixing of the resin and a 4-1/2-in. hole in the concrete to allow passage of the coupling of the long anchors and to provide adequate corrosion protection of the stressed bar. The contractor had difficulty extracting the cuttings from the hole supposedly because air velocity was reduced at the transition to the larger hole. The government directed the contractor to temporarily reduce the size of the larger hole by inserting a casing. After the contractor did this, he had much better success in extracting the cuttings.

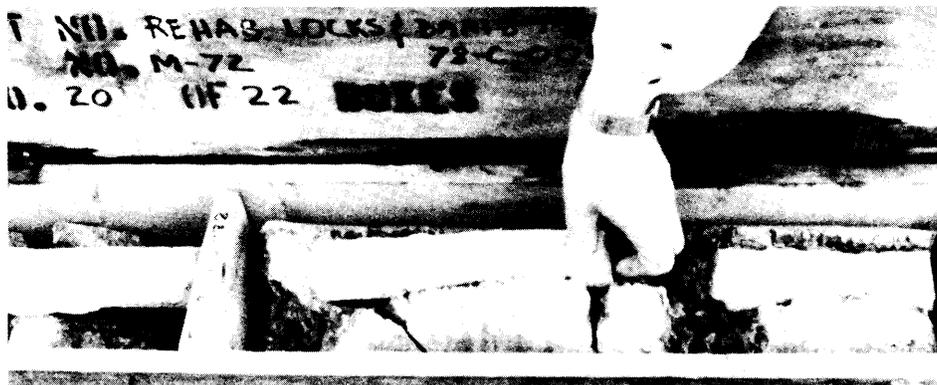
REASONS FOR FAILURE: A failed anchor was removed from the middle wall and closely examined for any possible explanation for the failure of the anchor. It was found that the resin between the deformation of the bar was still soft and pliable. In other reaches of the bar, the resin was not soft, and it was harder to remove from the bar. The contractor claimed that improper mixing occurred because the hole was enlarged due to the caving of the hole in the poor rock which would not have happened had he been allowed to pregrout each hole. To investigate the actual hole size, he was directed to core drill the hole where the failed anchor was pulled out. A reddish grout was allowed to set in the hole and the core drilling was successful in retrieving core within the rock and anchor hole (Figure 5). The diameter of the anchor hole was consistently

Figure 5. Core samples retrieved for testing

found to be 2-1/4 in. as the contractor intended. In the interest of finding the exact cause of failure, several boxes of resin cartridges with short lengths of anchor bars were sent to the Waterways Experiment Station in Vicksburg for testing. Their conclusion was that the size of hole chosen was borderline on being too large, and the semihardened condition of the hardening agent

required a greater amount of mixing than specified by the resin manufacturer's literature. A review of the shop drawing submittals indicated that the contractor may have inadvertently chosen the wrong hole size for the cartridge he was using.
