## REMR TECHNICAL NOTE HY-N-1.3

### GUIDANCE FOR REPAIRING SCOURED AREAS BELOW NAVIGATION DAM STILLING BASINS AND SPILLWAY APRONS

**PURPOSE:** To describe causes of scour below navigation dam stilling basins and spillway aprons and to identify methods and techniques being used to repair scoured areas.

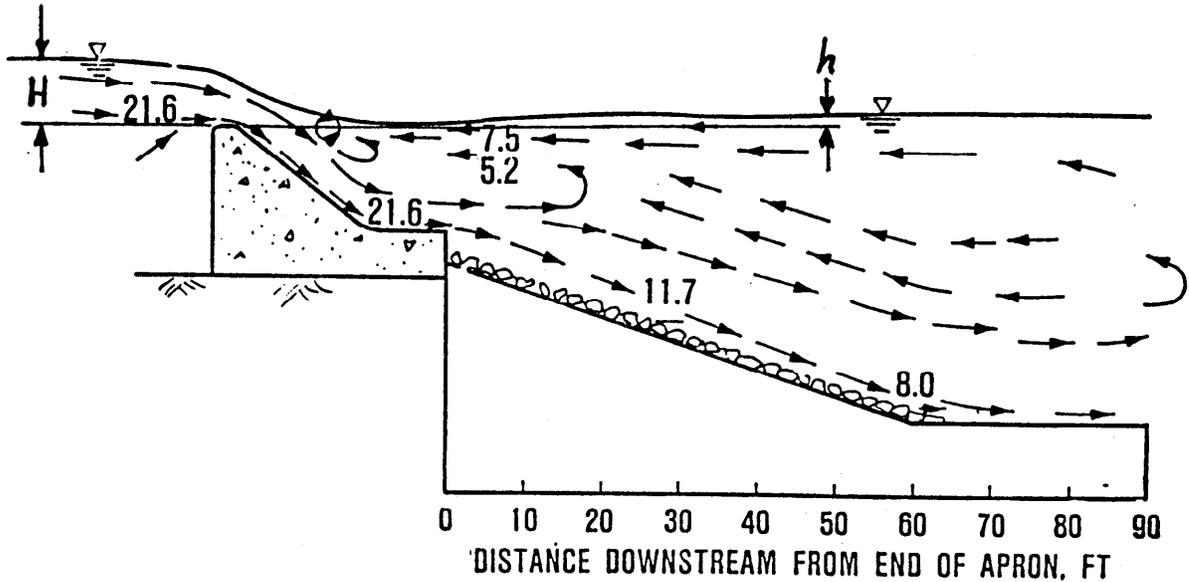
- a. Uncontrolled fixed-crest dams. Scour downstream from this type of structure is often caused by a plunging flow jet that exits the spillway apron at a high velocity as shown in Figure 1. This high-velocity jet causes severe turbulence capable of displacing large stone and uplift pressures that cause piping of the subgrade material. This flow condition when viewed from above appears as a gentle hydraulic roller, and the turbulence occurring on the bottom is not evident. The characteristics of the plunging jet are affected by discharge, tailwater, and the design or shape of the crest, spillway, and apron. Various combinations of these dictate when plunging flow will occur.

Review of data collected from previous model studies has generally indicated that, if the depth of tailwater above the crest,  $h$ , divided by the gross head on the crest,  $H$ , is below 0.8, plunging flow will occur. The shape of the crest will have an effect on the plunging flow. A curved spillway crest will induce the flow to cling to the face of the spillway, and the flow streamlines will exit parallel to the floor of the apron. A flat crest that has sharp edges causes the nappe of the jet with higher unit discharges to spring from the downstream corner away from the spillway and plunge through the tailwater downstream from the spillway apron severely attacking the area immediately below the dam.

Figure 1. Uncontrolled fixed-crest dam with plunging jet flow

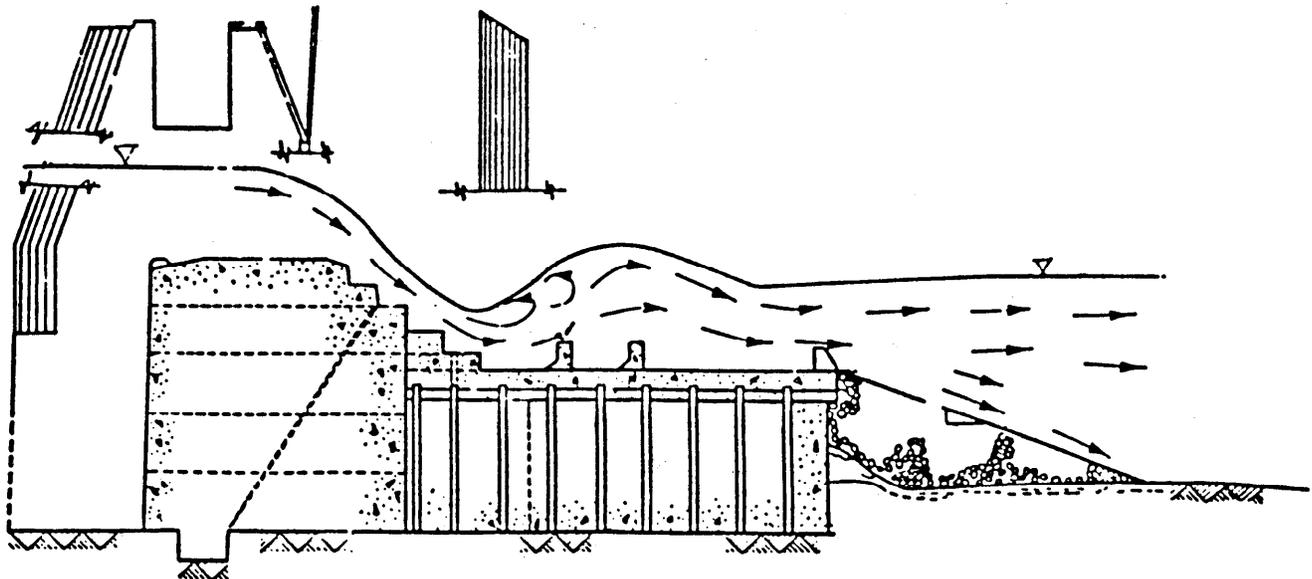
usually caused when the structure is not operated properly due to one or more of the following: operator error, equipment malfunction, vandalism, or operating the structure beyond its normal operation range to pass ice or debris. An example would be raising a single gate higher than the operation schedule allows in order to pass ice through the structure. The increased discharge due to the gate being raised higher than normal with the low tailwater causes significant turbulence in the downstream channel, often times resulting in severe scour and failure of the stone protection. This flow condition is depicted in Figure 2.

Figure 2. Gated structure with normal upper pool, one gate full open, and minimum tailwater

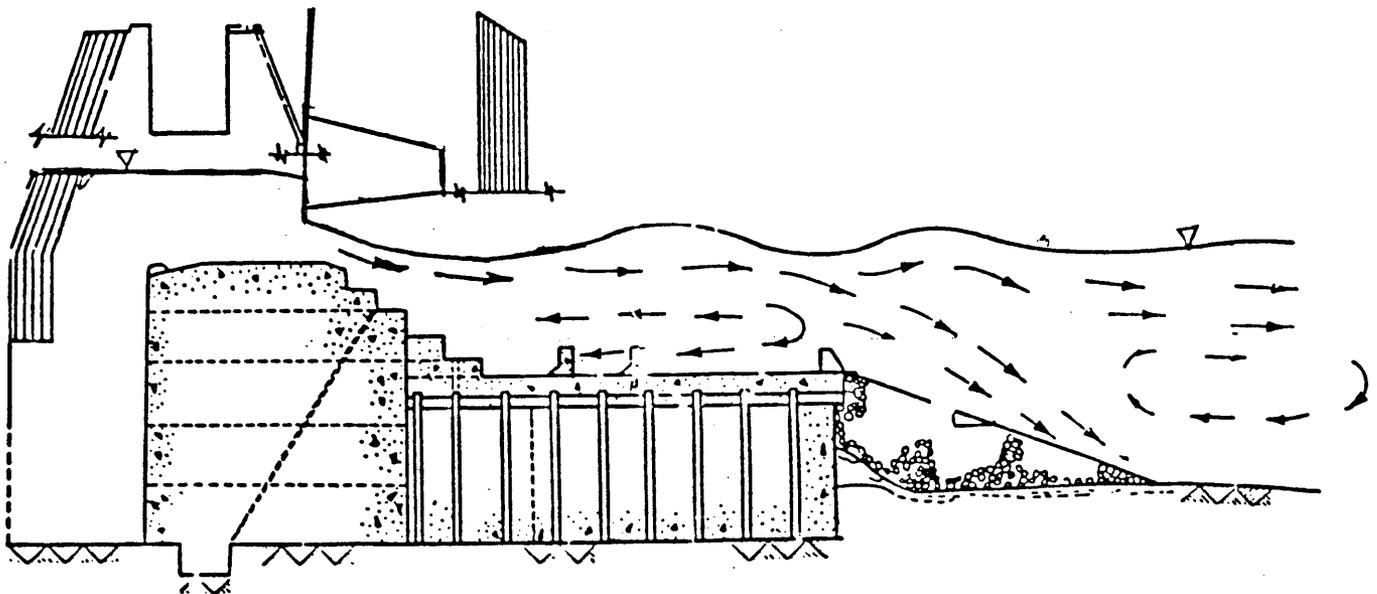
Another flow condition that has been observed to cause scour downstream from a gated structure is an undulating jet. This occurs when high tailwater forces the flow entering the basin to undulate and ride the surface of the tailwater through the basin and then plunge through the tailwater after leaving the basin. This flow condition is shown in Figure 3. The plunging jet often is strong enough to reach the streambed or the stone protection and cause scour.

Figure 3. Gated structure with undulating jet flow
