An Evaluation of Materials for Repair of Erosion Damage in Hydraulic Structures

by James E. McDonald

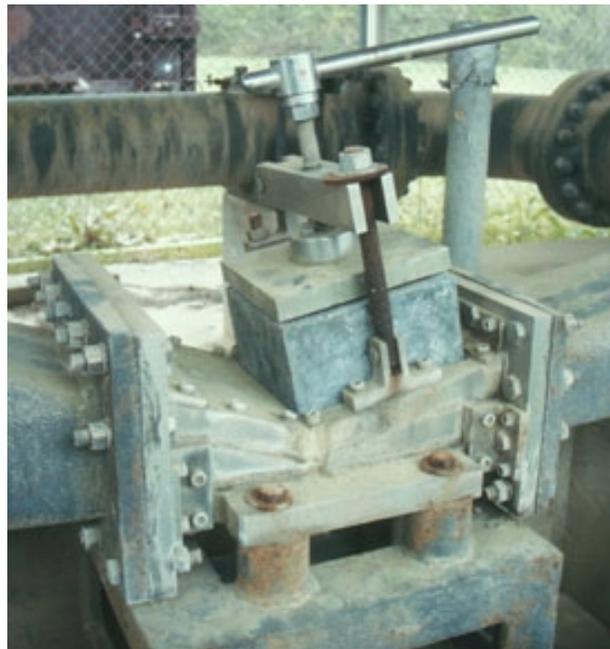
Figure 2. Cavitation apparatus after installation of test specimen

A series of calibration tests on the apparatus was necessary to ensure that vapor bubbles created during operation would collapse in the area directly under the relatively small test specimen (Figure 2).

The surface area of the test specimen exposed to the high-velocity flow and cavitation is approximately 150 cm².

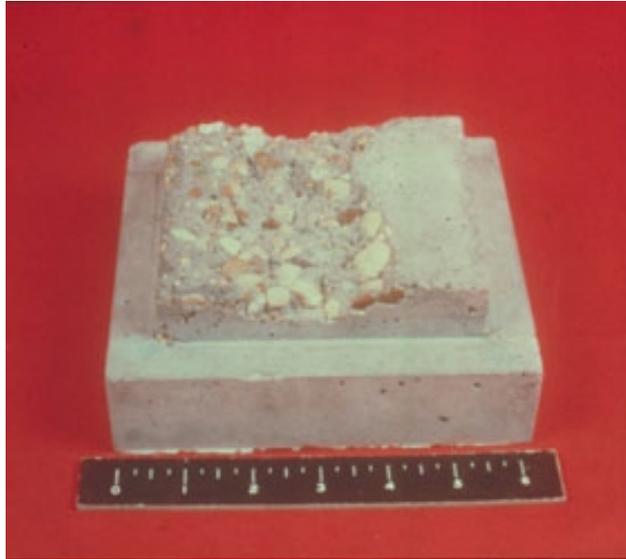
Figure 3. Conventional concrete after 2-hr exposure

The apparatus produces a moderate to slightly severe cavitation environment. Two hours exposure in this environment results in significant cavitation damage to conventional concrete with a compressive strength of 35 MPa and nominal 10-mm maximum size aggregate (Figure 3).
