Grout-Enriched Roller-Compacted Concrete— Phase I Investigation

by James E. McDonald

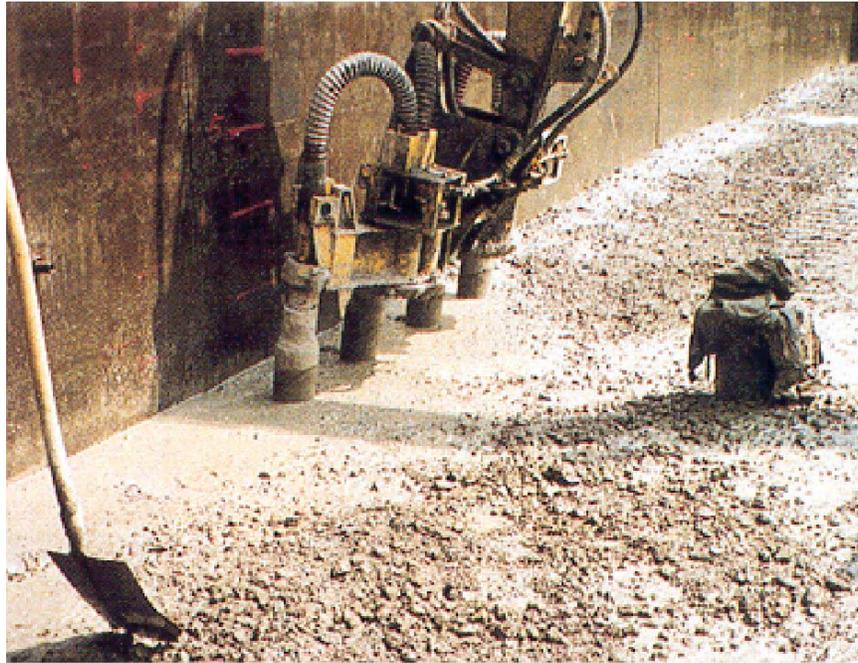
Figure 1. Consolidation of GE-RCC along upstream face of dam
(after Forbes 1999)

Grout-enriched RCC (GE-RCC) has been used on some recent projects to provide durable RCC surfaces with reduced permeability. In this approach, cementitious grout is poured over about a 0.4-m (1.3-ft) strip of the RCC lift surface along the vertical formwork. Once the grout soaks into the RCC, the mixture can be successfully consolidated with internal vibrators (Figure 1) to form a homogenous, impervious RCC facing.²

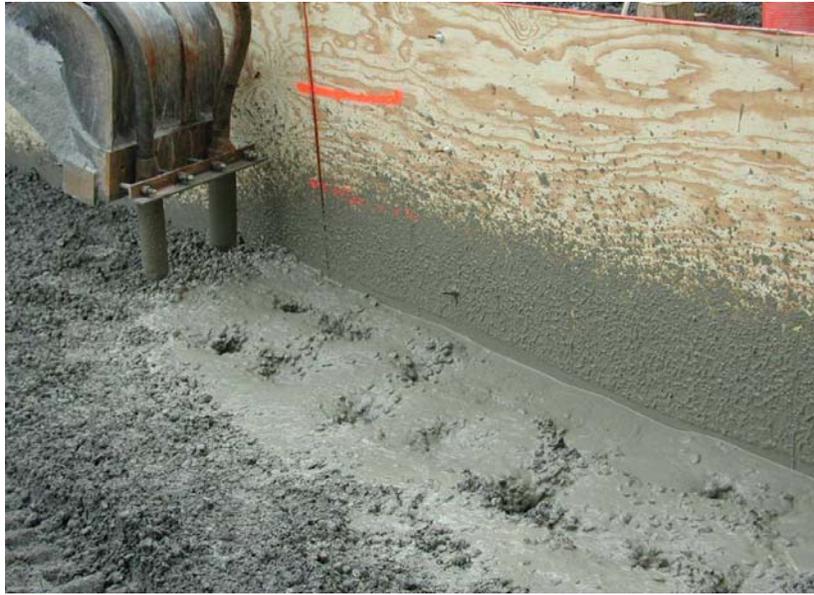
Figure 6. Vibration of Lift 1, Zone B

The grout in Zone B was placed on top of the RCC lift, and internal vibration was provided with two 3-in. vibrators mounted on a small hydraulic backhoe (Figure 6). The grout appeared to be too thick to

permeate down through the RCC, and an insufficient quantity of grout was placed on top of the RCC. The vibrators made post-holes in the RCC, which then filled with grout. The grout did not appear to be mixed into the RCC.

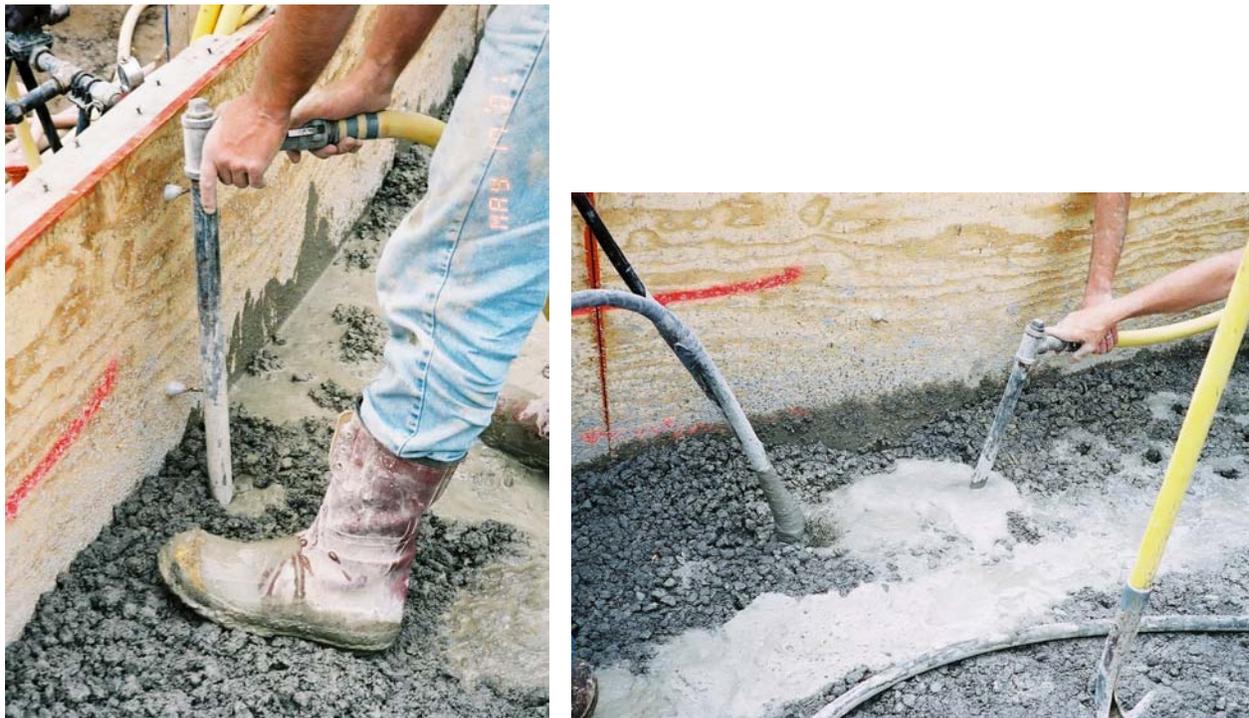
Figure 7. Grout injection with a stinger pipe and consolidation with internal vibration

In Zone B, the grout was injected into the RCC with a stinger pipe with a closed, pointed end and holes drilled into the sides (Figure 7). The stinger was approximately 1-in. in diameter with 3/8-in.-diam holes. The RCC was placed to the full lift thickness, spread, and tracked into place with a dozer. The stinger was then inserted into the RCC at approximately 12 in. on center, and grout with a 1.5 w/c was injected. The stinger could only be inserted a few inches by hand, and further insertion required driving with a rubber mallet. The need for driving slowed the process; however, grout injection progressed smoothly and grout was observed penetrating into the RCC and into previous injection holes. The GE-RCC was vibrated with a 2-in. vibrator, and the grout appeared to be fairly well dispersed within the RCC. Vibrator holes would close with adjacent vibration.

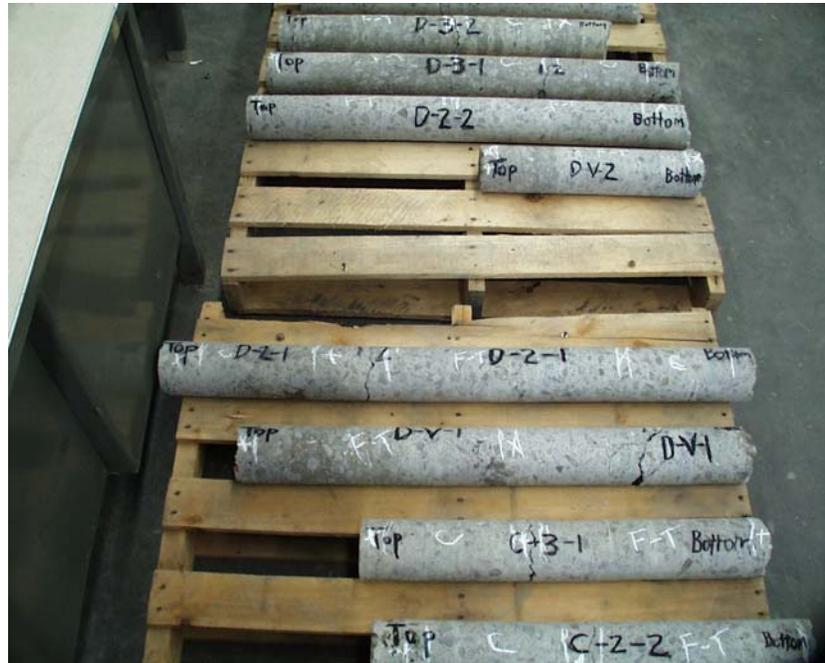
Figure 9. Typical condition of GE-RCC cores

A visual examination indicated that the GE-RCC cores were in generally good condition, as shown in Figure 9. Based on the visual examination, portions of the cores were designated for specific tests and the specimens were sawed to appropriate lengths. For example, the transverse marks on the cores shown in Figure 9 are locations for saw cuts. The symbols x, F-T, and C (marked in white) identify specimens for hardened air content, freeze-thaw resistance, and compressive strength tests, respectively. In addition, the density of each freeze-thaw and compressive strength specimen was determined prior to testing. It was attempted to select the specimens in a manner that would provide a profile of material properties from the
