REMR TECHNICAL NOTE CS-MR-8.4

CASE HISTORY OF IMPROVING STRUCTURAL STABILITY OF CONCRETE STRUCTURES ON ROCK: INSTALLATION OF ROCK ANCHORS TO IMPROVE STABILITY AGAINST SLIDING, ALUM CREEK DAM*

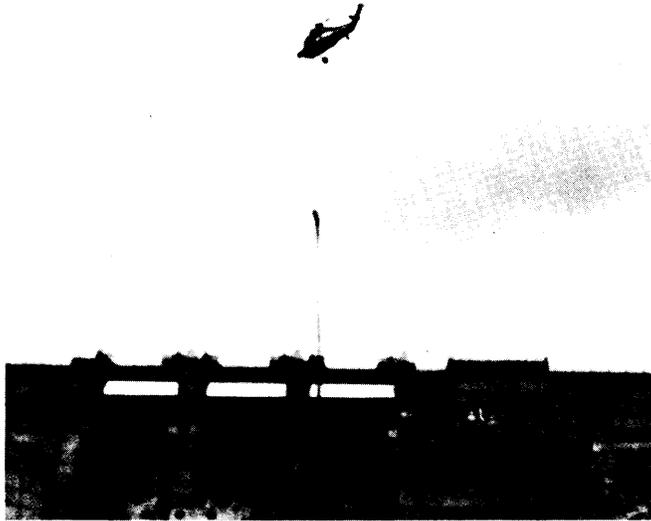
Figure 4. Helicopter was used to install anchors

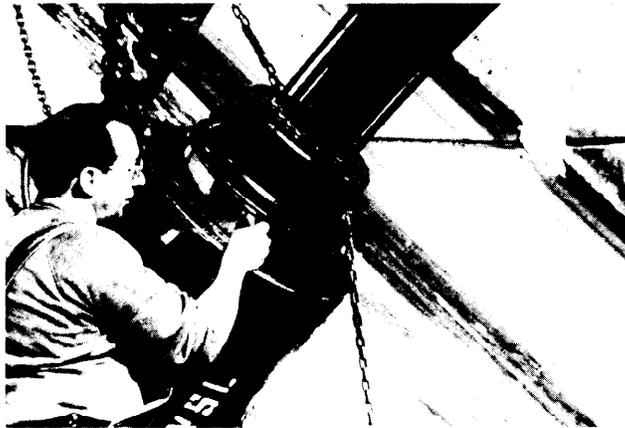
After the first stage (grouting reached a compressive strength of 4000 psi), the anchors were stressed. Each of the 52 strands was individually pulled to 3 kips each, to take the slack out of the system, prior to simultaneous stressing to 29.4 kips per strand or 1528.8 kips per anchor. The load of 1528.8 kips was applied by a 1000-ton centerhole jack (Figure 5). The loads were determined by a pressure gage on the jack reading to the nearest 100 psi.

Figure 5. Reading pressure gage on centerhole jack
