Engineer Research and
Development Center

Application of a Regional Sediment Approach to Hickahala Creek Watershed, Northern Mississippi

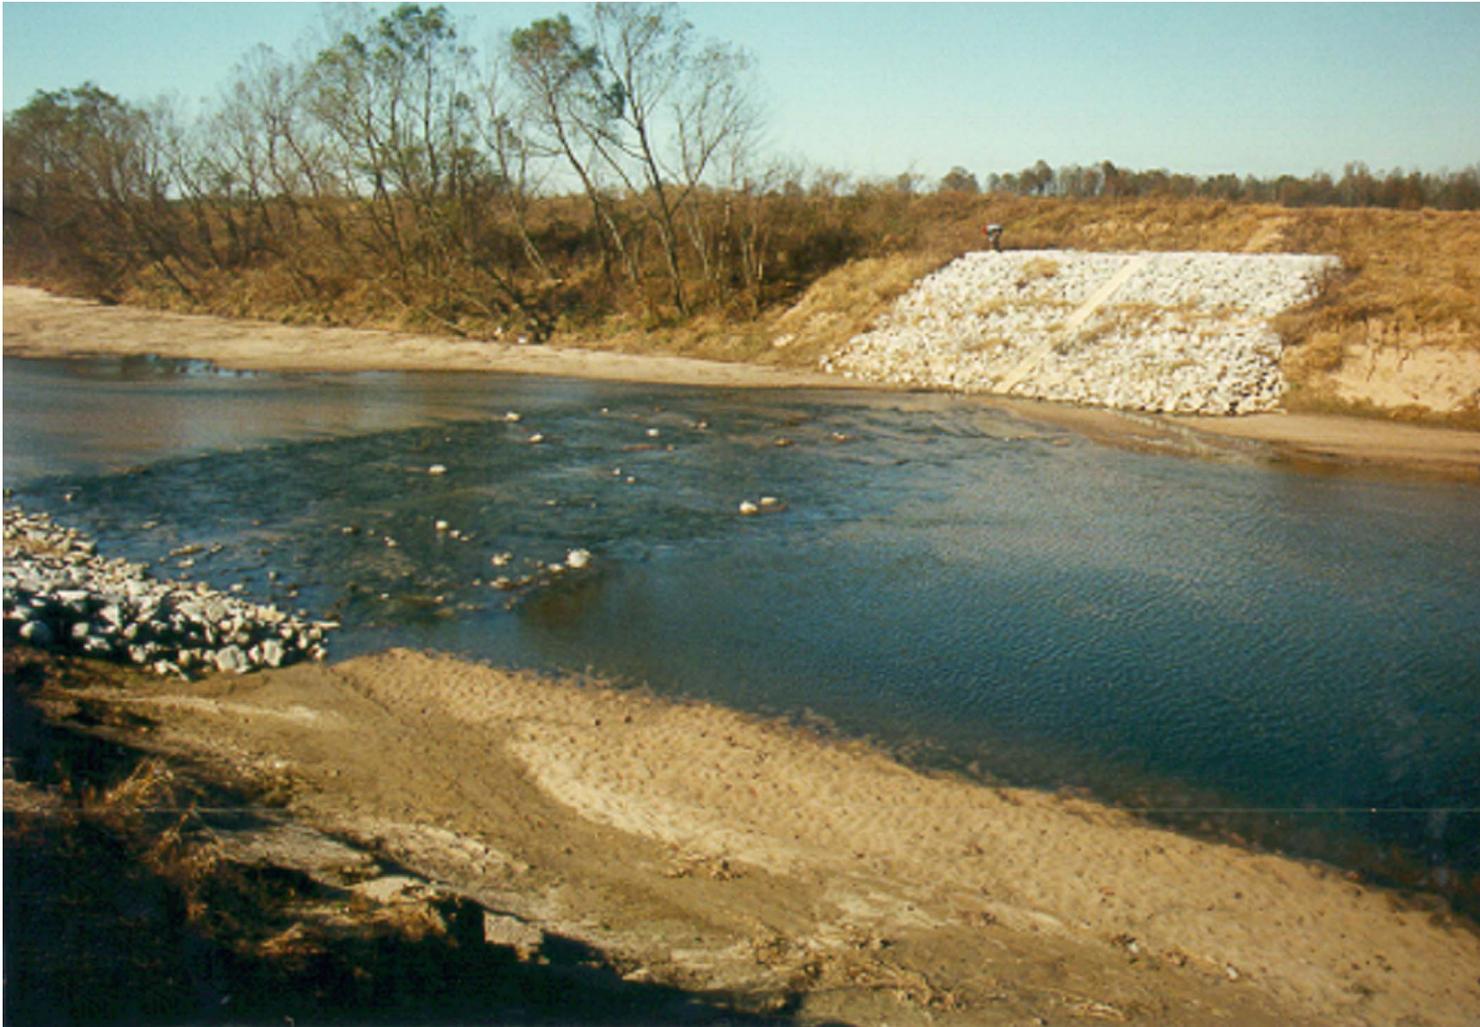
Figure 6. Initial riprap sills

An important component of the channel improvement project was the construction of the erosion control features in the upper watershed. Perhaps some of the most important structures, at least in the short term, were the two riprap sills constructed just upstream of the upper limits of the project on Hickahala and Senatobia Creeks. These sills were initially constructed at the existing bed elevation with no drop across them (Figure 6). However, a 2003 field inspection of these structures revealed about 1m of drop across each structure (Figure 7). Had these structures not been built, approximately 1 m of additional bed lowering would have advanced upstream for many kilometers resulting in accelerated sediment supply to the downstream project area. This increased sediment load would have severely impacted the longevity of the project. Additionally, riprap sills were also constructed near the mouths of all tributaries entering the project area.
